A Case Study of Observational Method for a Failed Geotechnical Excavation in Singapore

Y. Iwasaki

Executive Director, Geo-Research Institute, Osaka, <yoshi-iw@geor.or.jp>

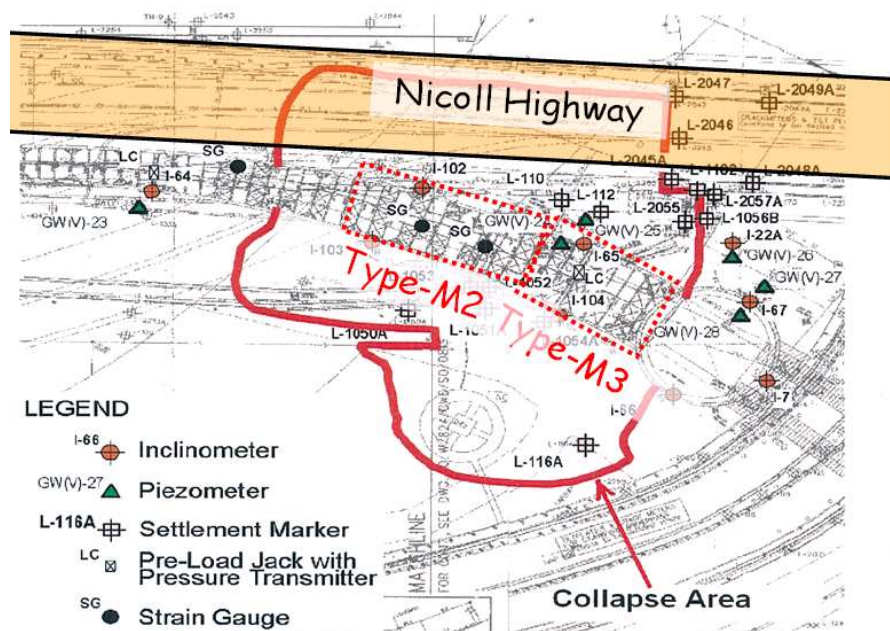
Fig.1 General Plan view

As shown in Fig.1, the section is parallel to the existing Nicoll Highway on the ground surface and consists of different types of retaining wall including M2 and M3 that failed as shown in Fig.1.

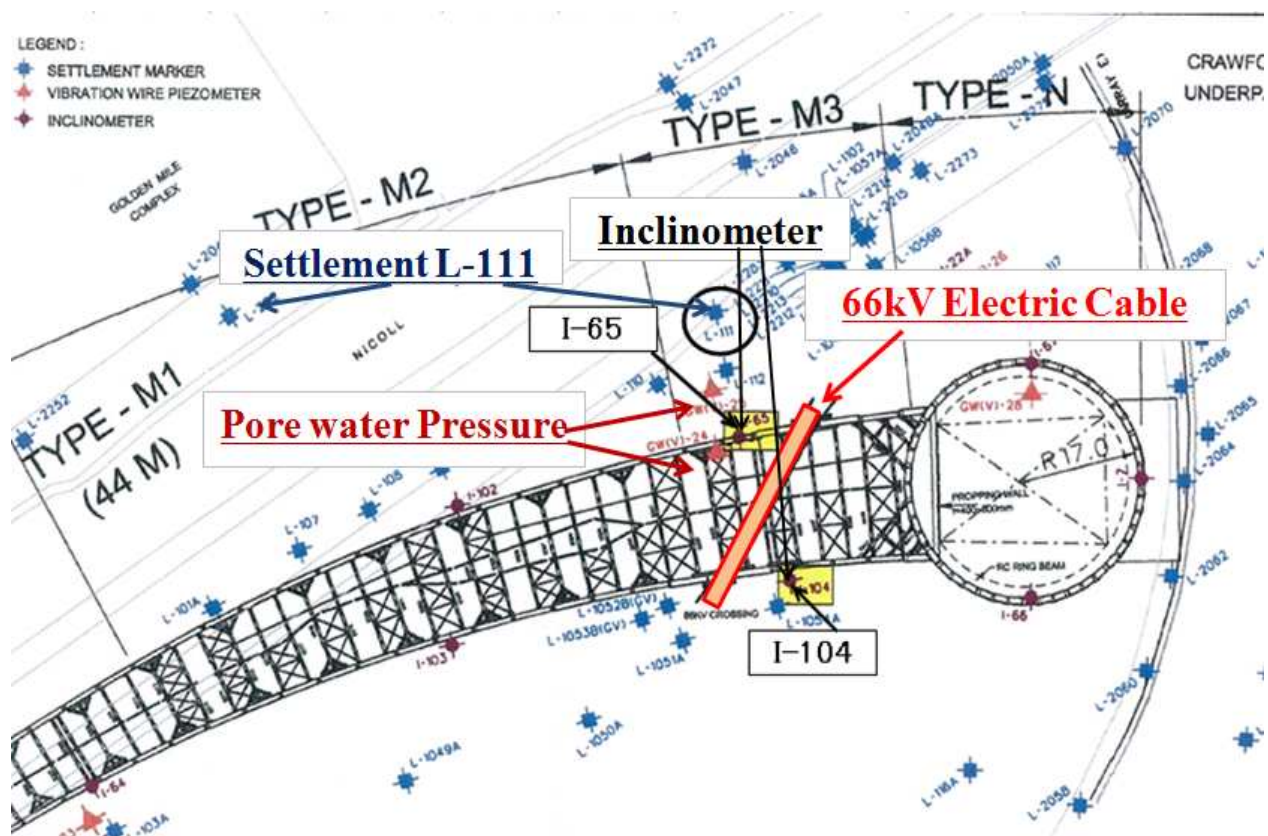
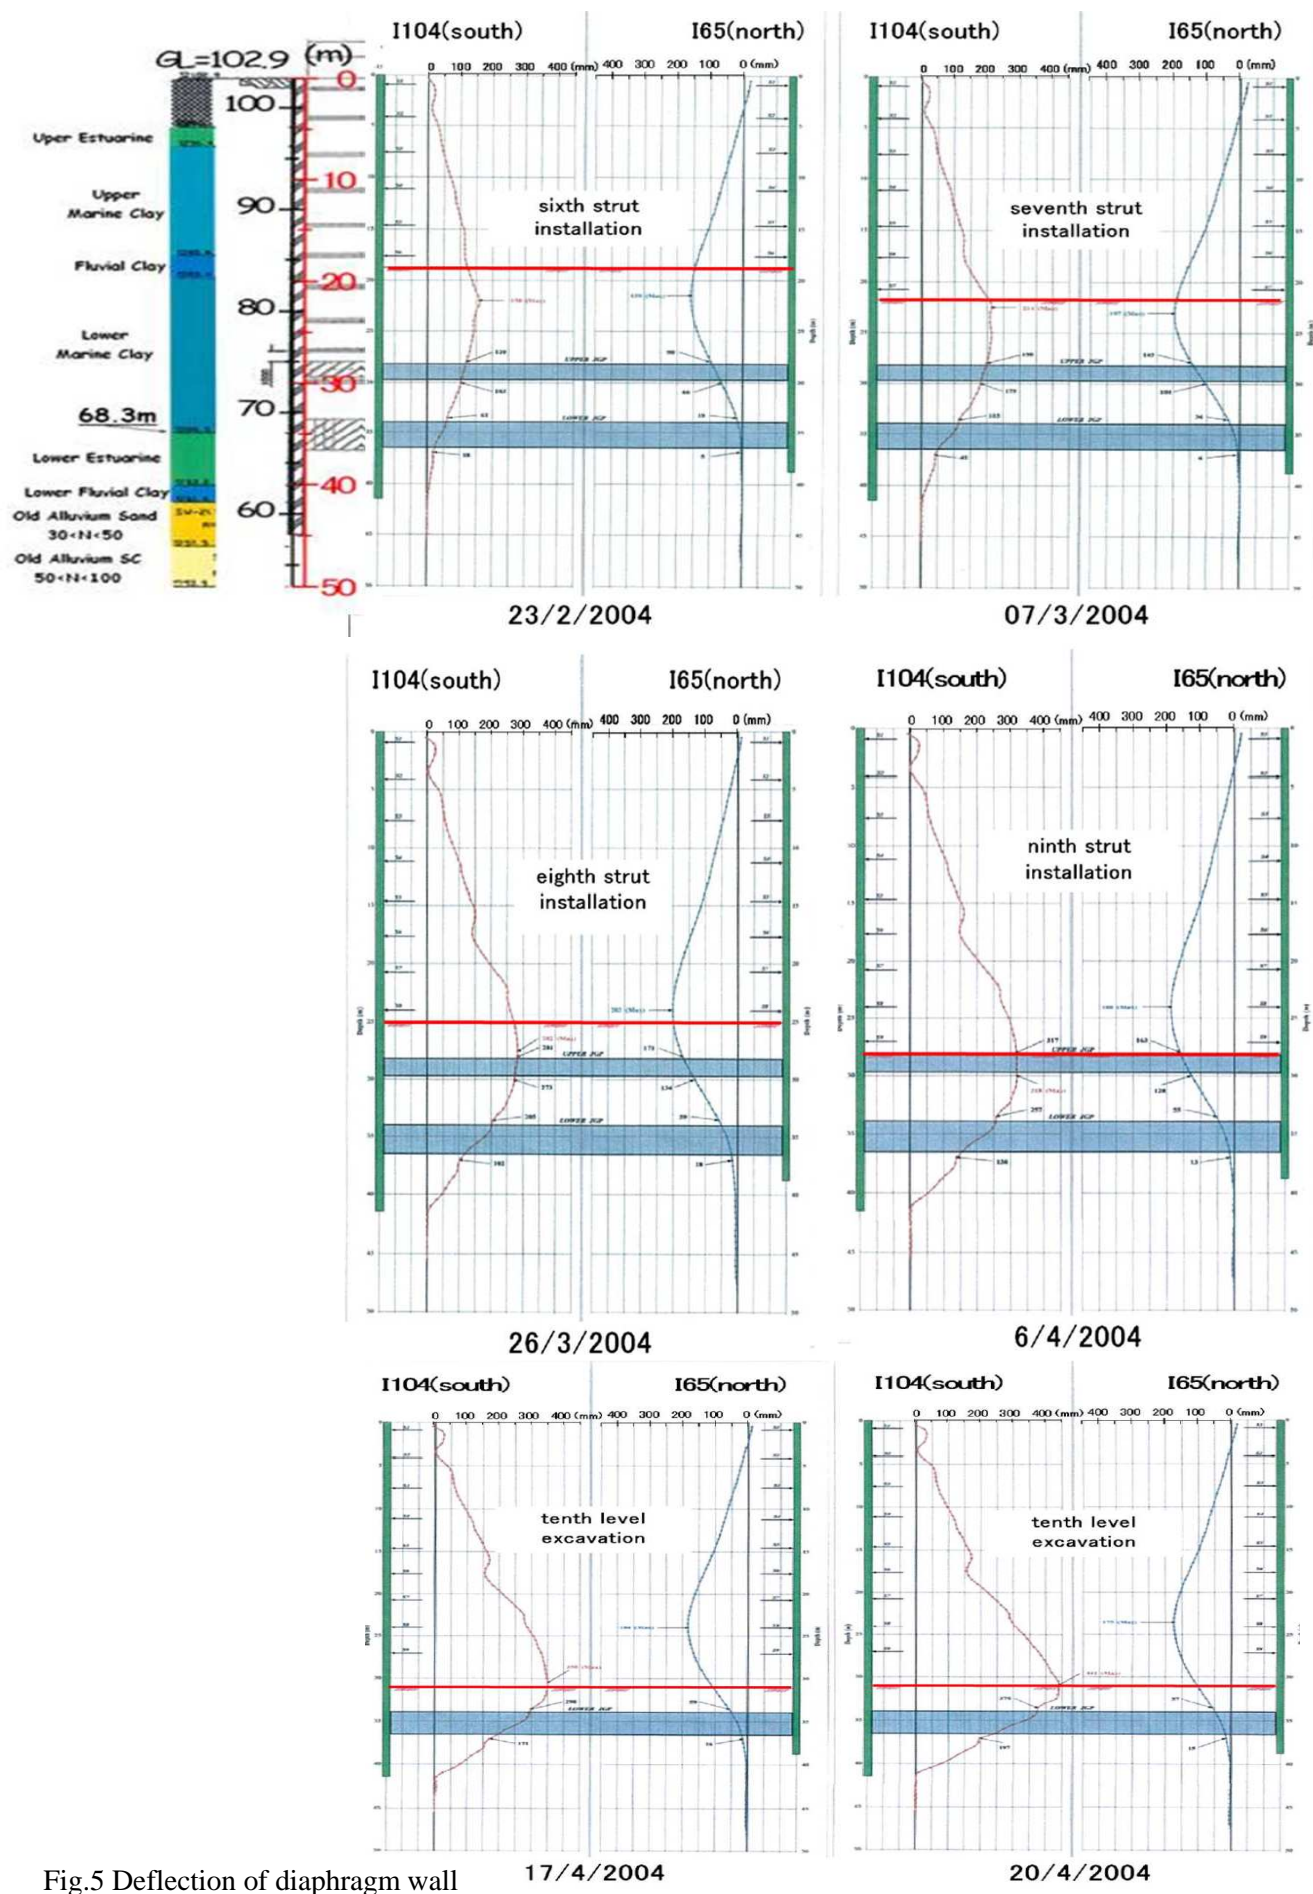
Fig.5 Deflection of diaphragm wall

Excavation started on 26 September, 2003, at the M3 Section. The monitored wall deflections from the six strut installation until before the failure took place are shown in Fig.5 as well as chronological time change of excavation with strut and the maximum deflection for I-65 and I-104 in Fig.6.

As shown in Fig.5 and Fig.6, the deflection after the sixth strut installation, the total deflection had reached 35cm, which resulted in about 1.7%.

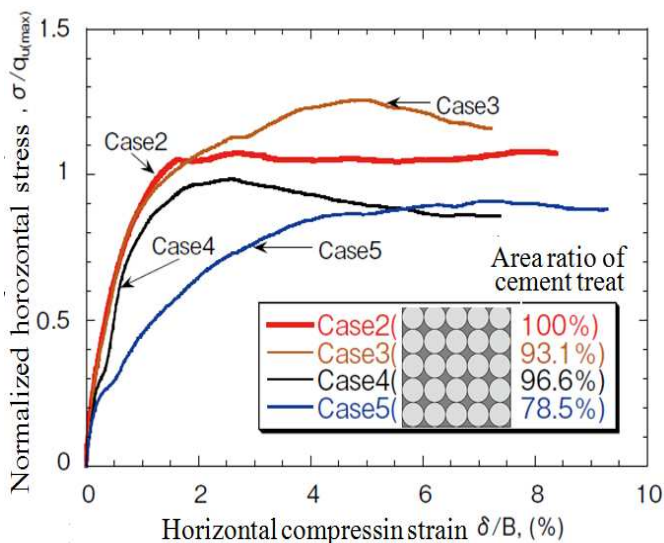
Fig.7 Stress-strain for JGP (Imamura et al.(2008))

Fig.7 shows basic stress and strain for horizontally loaded JGP obtained by laboratory tests (Imamura et al., 2008). The vertical stress was normalized by dividing horizontal stress by the unconfined compression strength of column of JGP (500kPa). Fig.7 shows the maximum allowable horizontal strain is estimated as 2%.

If safety margin is given as $FS=2$, the allowable deflection at the level of JGP is 1%, which is 20cm in total, or, 10cm for each side.

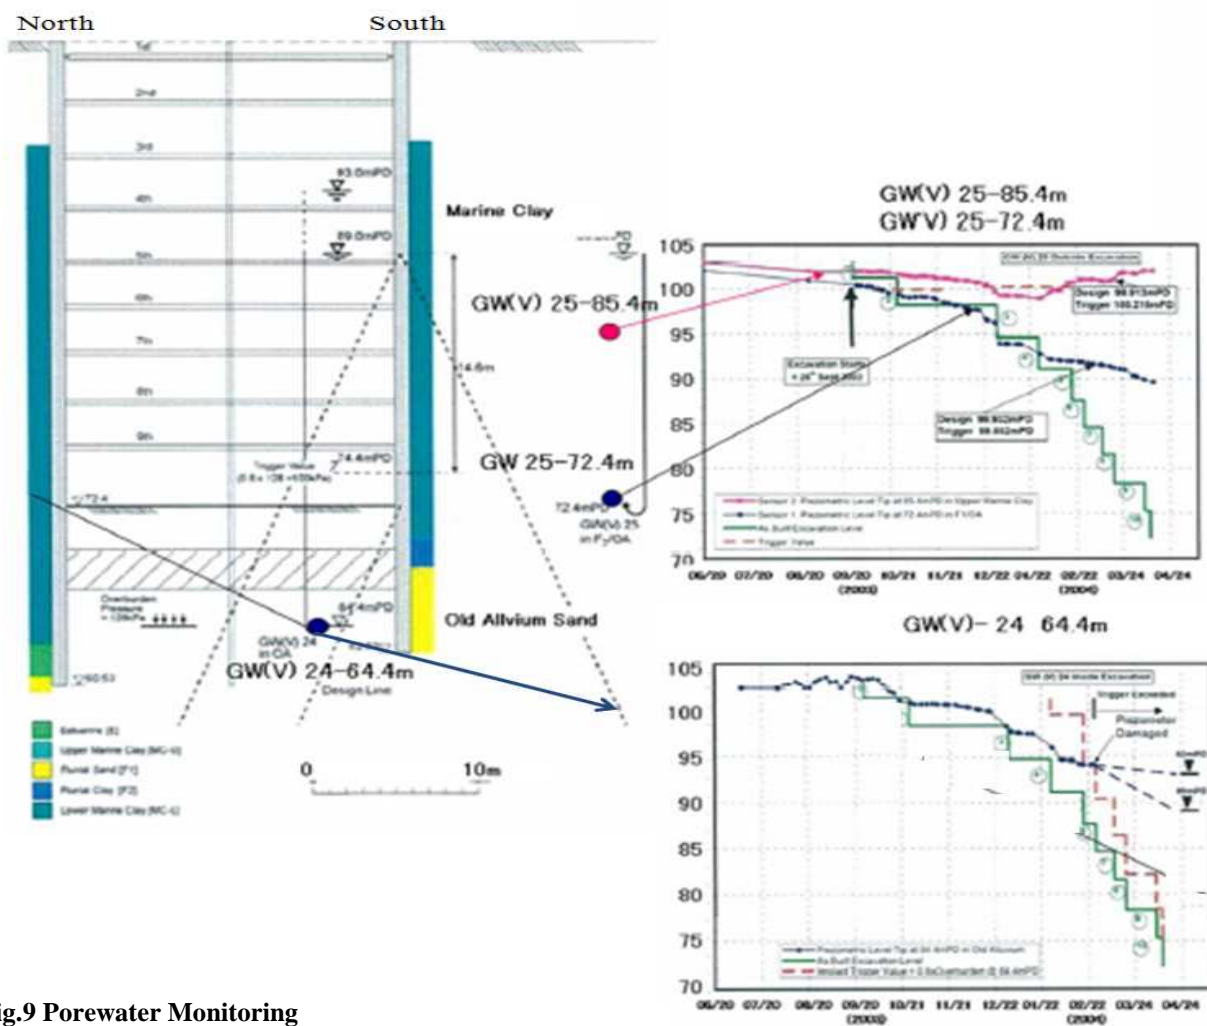
Fig.9 Porewater Monitoring

The pore water pressure was monitored at two depths at $GL-17.5m$ and $-30.5m$ of behind the diaphragm wall. The ground water was observed $GL-2m$ in general in the area.

The porepressure at $GL-17.5m$ had gradually decreased with excavation stage.

The decrease of the pore water pressure might be caused by inwards movement of the diaphragm wall that had resulted in volume expansion of the soil behind the wall.

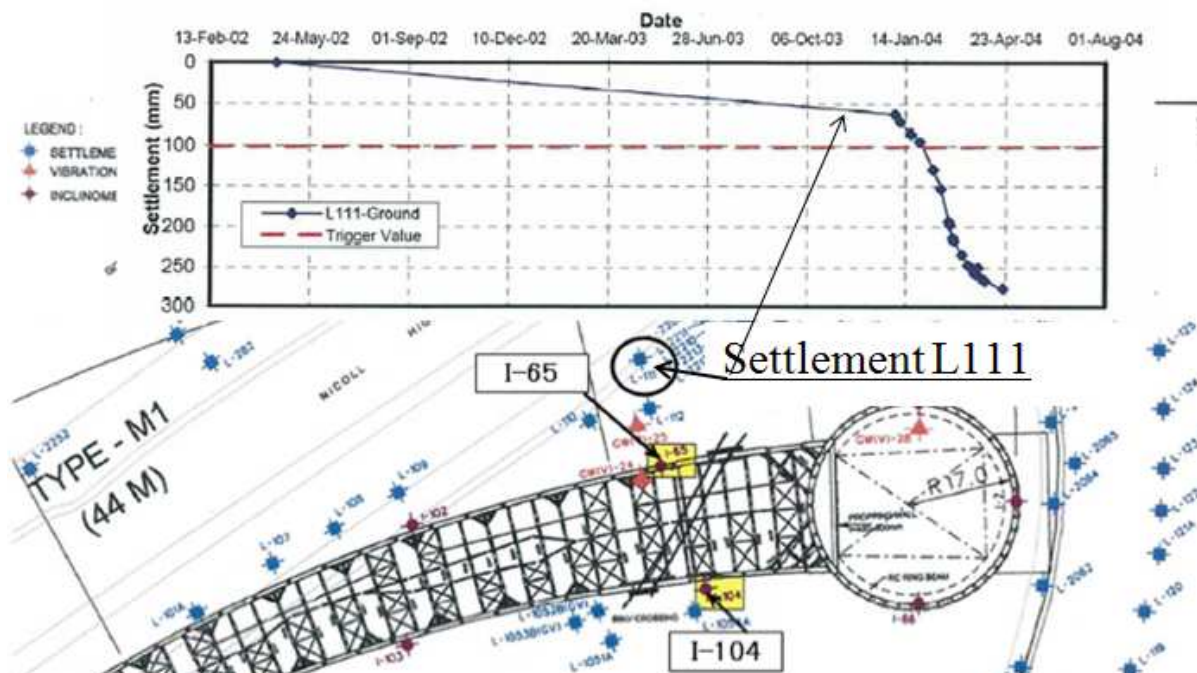
Fig.10 Settlement Gage at L111 and monitored result

monitoring had been installed for the evaluation. Pore water measurements had been also installed near the retaining wall as shown in Fig.9. One of the typical settlement installed at L111 was shown in Fig.10. The level of the ground surface was $GL=+102.9m$ RL.

The ground settlement at L111 was gradually had taken place and reached about 10cm in January 2004. After this point, the settlement had increased rather rapidly with time.

The settlement at L111 was caused either by consolidation or displacement of diaphragm wall.

Since the settlement was increased so fast, the settlement was very likely considered by the movement of diaphragm movement.

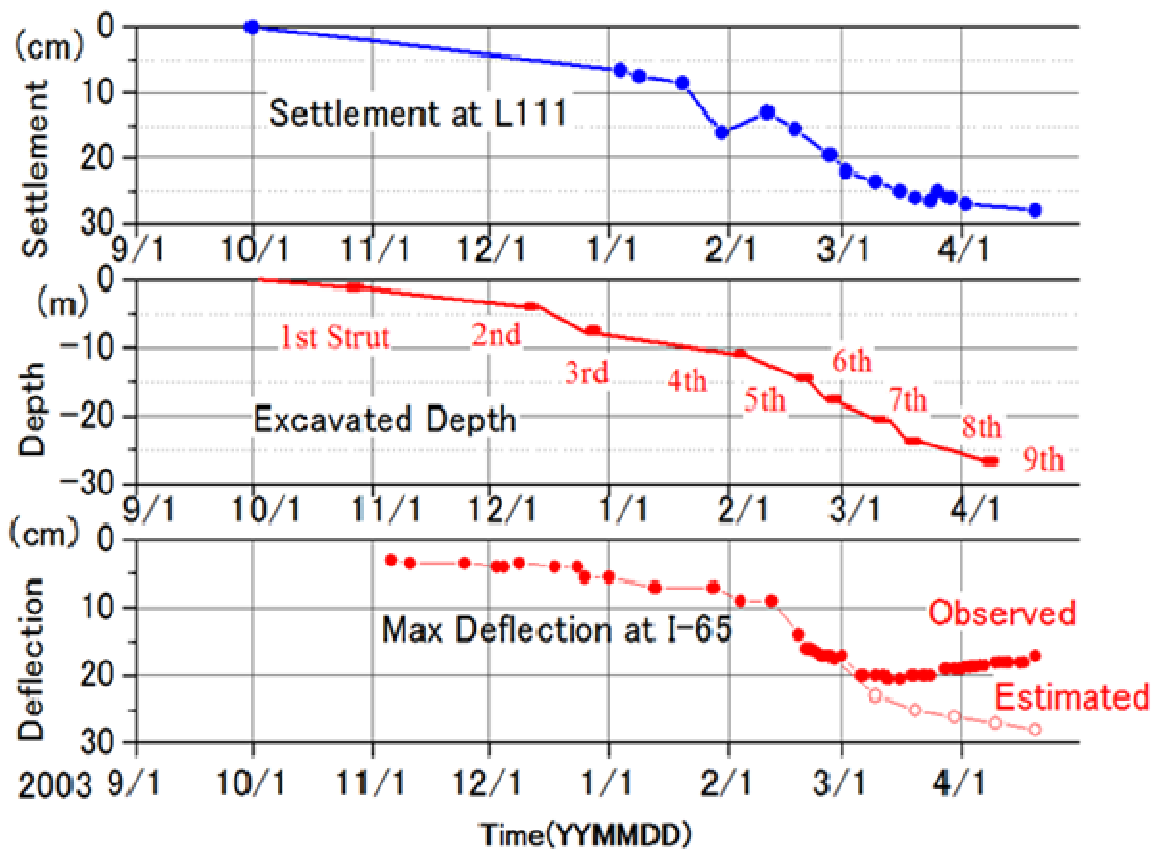
Fig.11 Settlement vs. Deflection

Fig.11 shows a comparison between the max deflection at I-65 and settlement at L-111 with the same time scale.
